2017 Independent Environmental Audit

Port Kembla Coal Terminal

Client: Port Kembla Coal Terminal Pty Ltd

08-Jun-2017

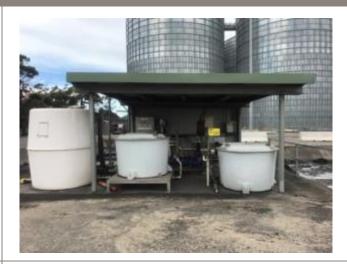
5-6. The flocking station at the Settlement lagoon contained three fibreglass aboveground storage tanks containing. None of the aboveground storage tanks had secondary containment.

Refer to OFI-2017-09.

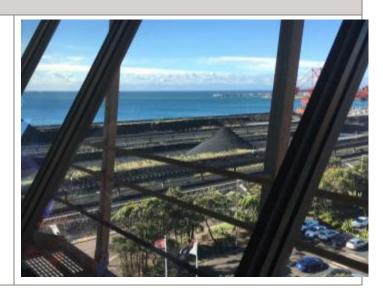
5-8. Coal Stockpile and water spray system

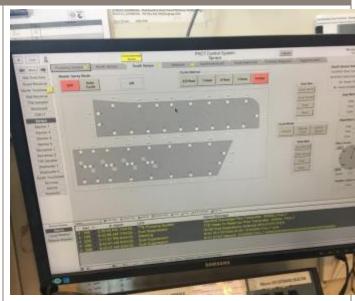
5-18. Control room spray system for the temporary stockpile area in the south of the site. Stockpile areas were not in use on the day of the inspection.

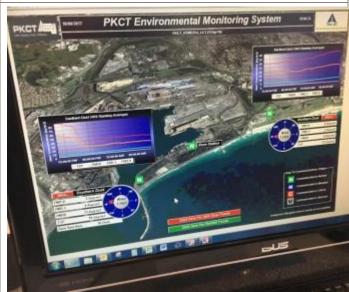
5-19. Control room environmental monitoring data screen showing meteorological data and dust monitoring data.
