PORT KEMBLA COAL TERMINAL
APRIL 2012 COMPLIANCE MONITORING

REPORT NO. 07355-NM-5
VERSION A

MAY 2012

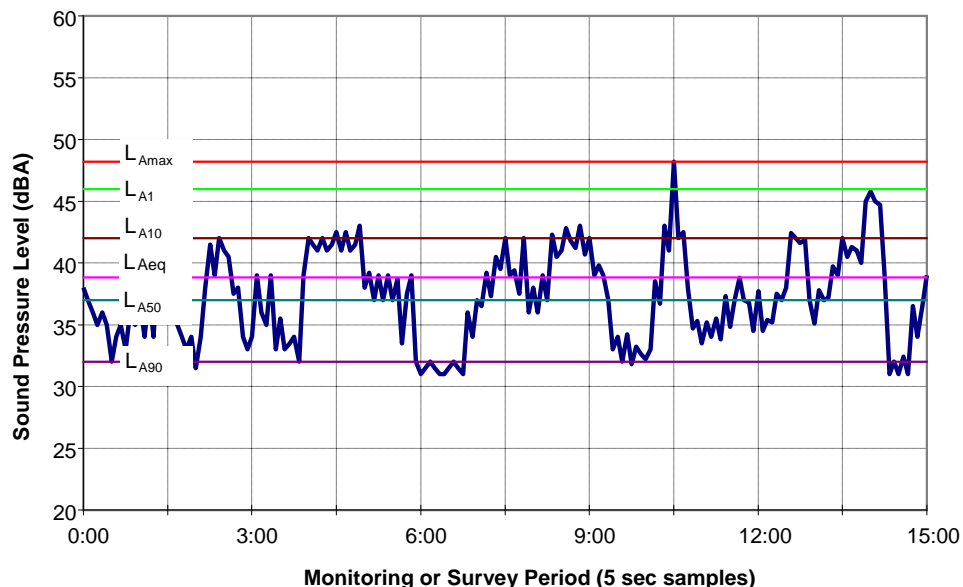
Most environments are affected by environmental noise which continuously varies, largely as a result of road traffic. To describe the overall noise environment, a number of noise descriptors have been developed and these involve statistical and other analysis of the varying noise over sampling periods, typically taken as 15 minutes. These descriptors, which are demonstrated in the graph below, are here defined.

Typical Graph of Sound Pressure Level vs Time

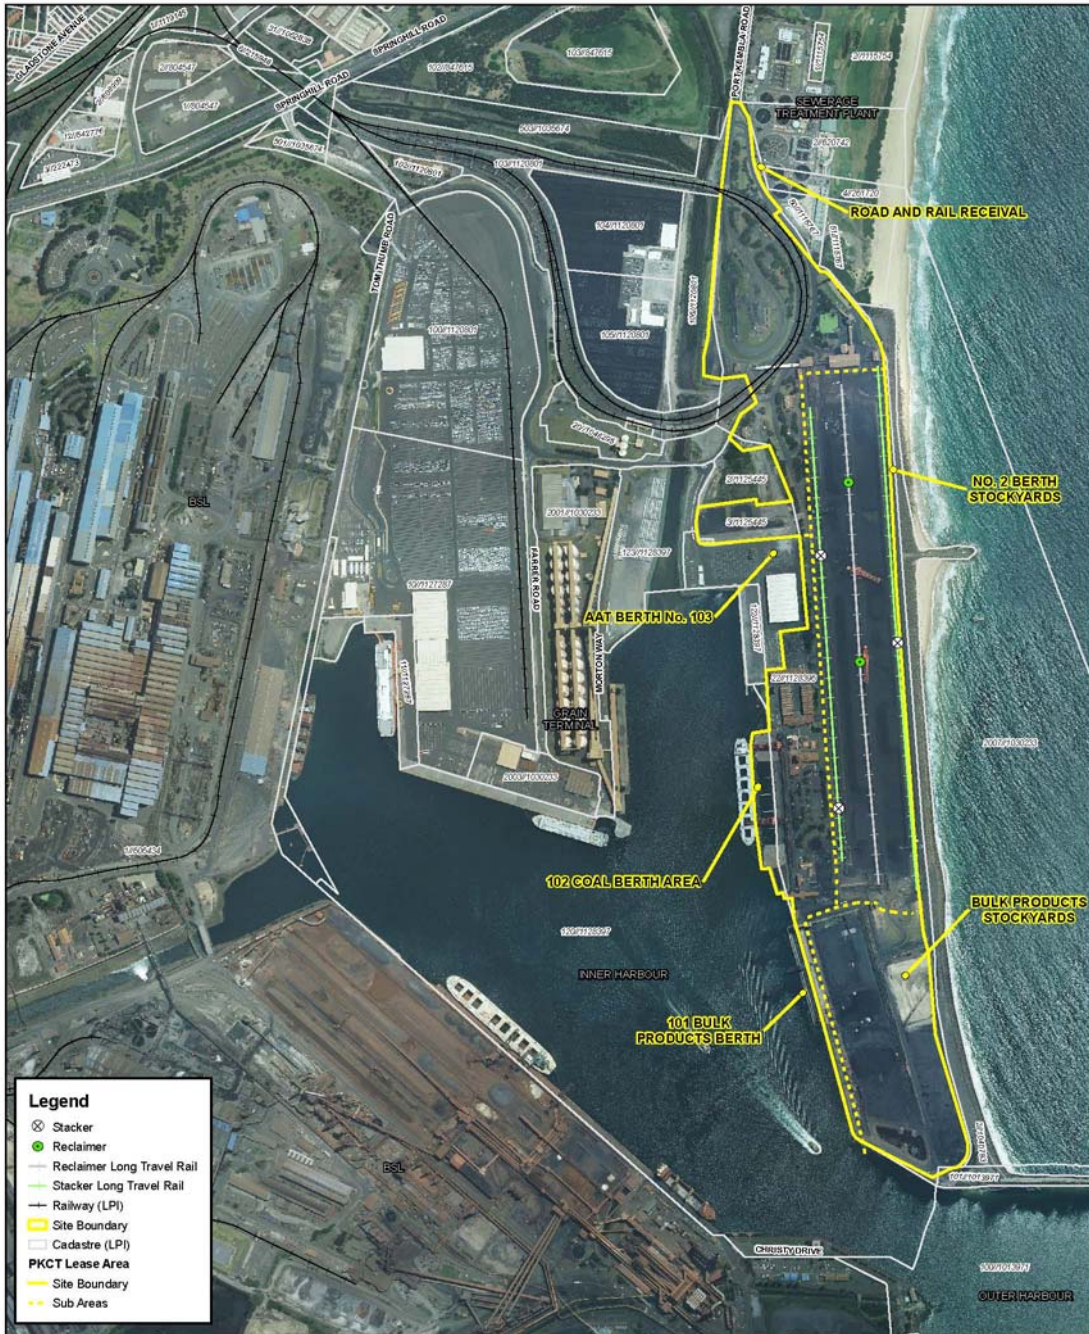
Figure 2-1 Site Plan for PKCT

Figure 2-1 and **Figure 2-2** shows the site plan of the PKCT site and its location relative to the surrounding receivers, respectively.

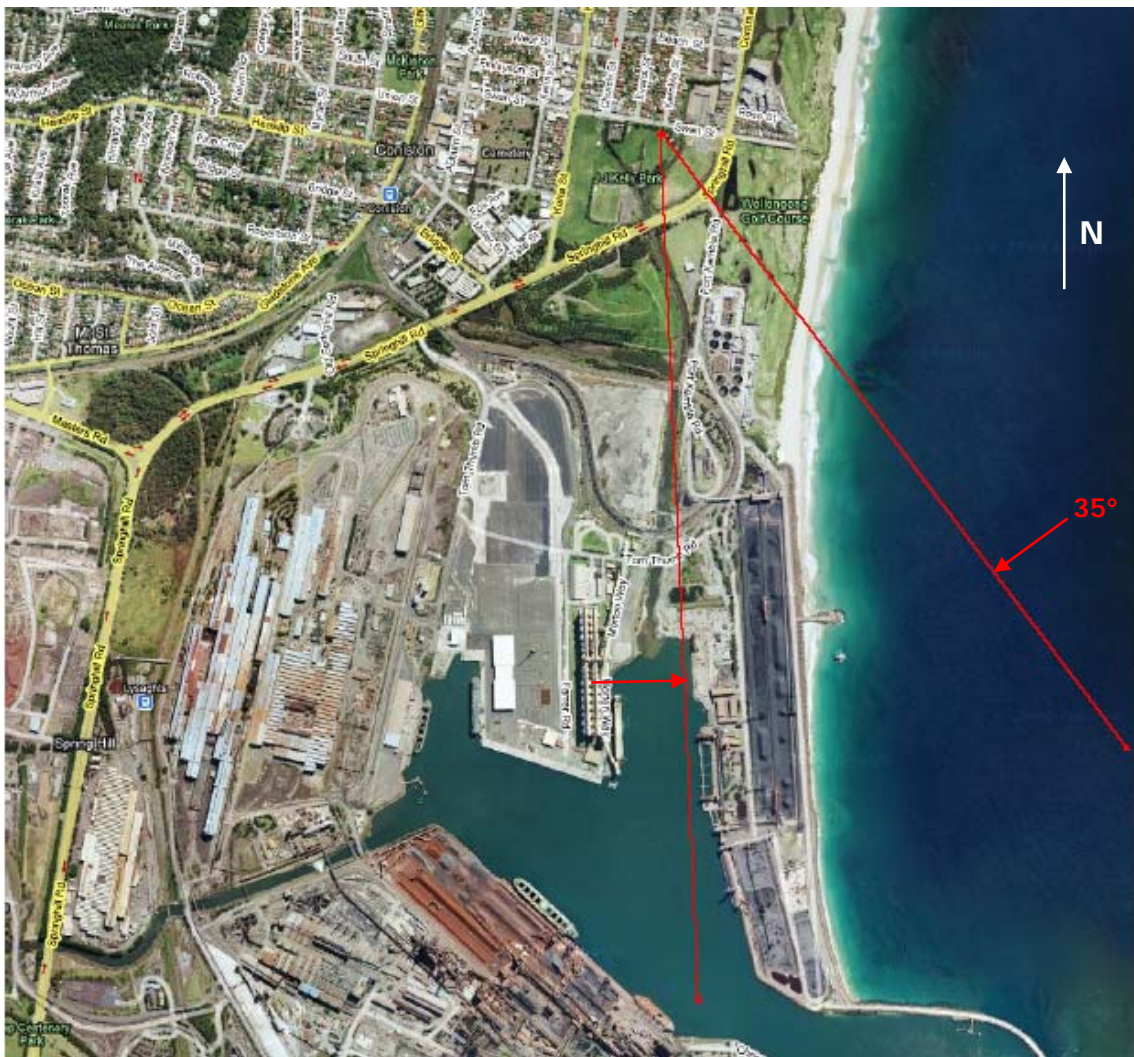
Figure 4-1 Monitoring Location 1 – Corner Swan & Kembla Streets

Figure 4-1 to **Figure 4-3** show the monitoring locations and the relative angular exposure to the PKCT operations. **Figure 4-4** shows the approximate locations where observations and measurements were taken in the vicinity of the receival area.

These sources were included in the BarnOwl[®] measurement segment (see **Figure 4-1**, **Figure 4-2** and **Figure 4-3**) and as such have been included in the measurement contribution from the PKCT site.
