PORT KEMBLA COAL TERMINAL
DECEMBER 2013 COMPLIANCE MONITORING

REPORT NO. 07355-NM-8
VERSION A

JANUARY 2014

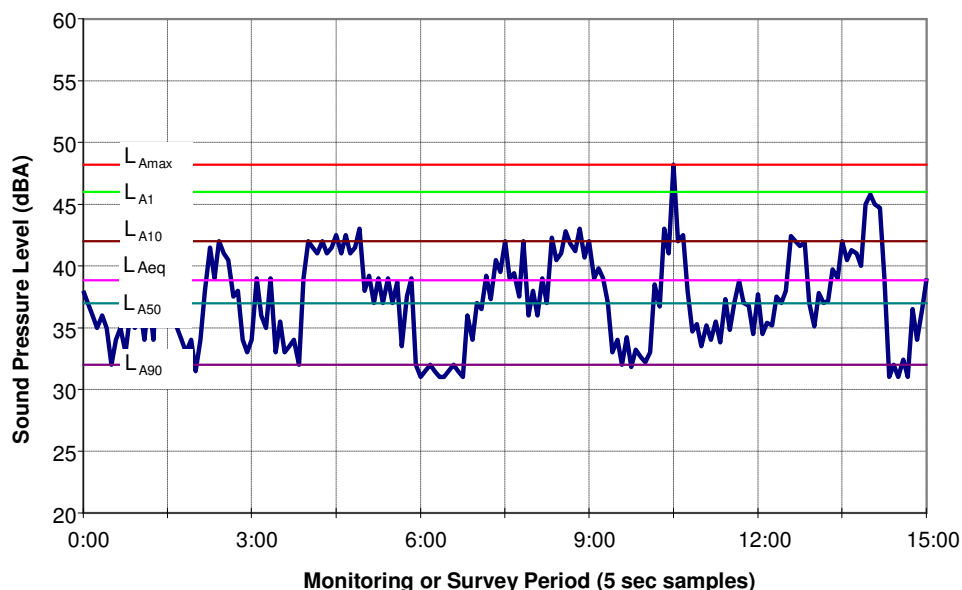
Typical Graph of Sound Pressure Level vs Time

Most environments are affected by environmental noise which continuously varies, largely as a result of road traffic. To describe the overall noise environment, a number of noise descriptors have been developed and these involve statistical and other analysis of the varying noise over sampling periods, typically taken as 15 minutes. These descriptors, which are demonstrated in the graph below, are here defined.

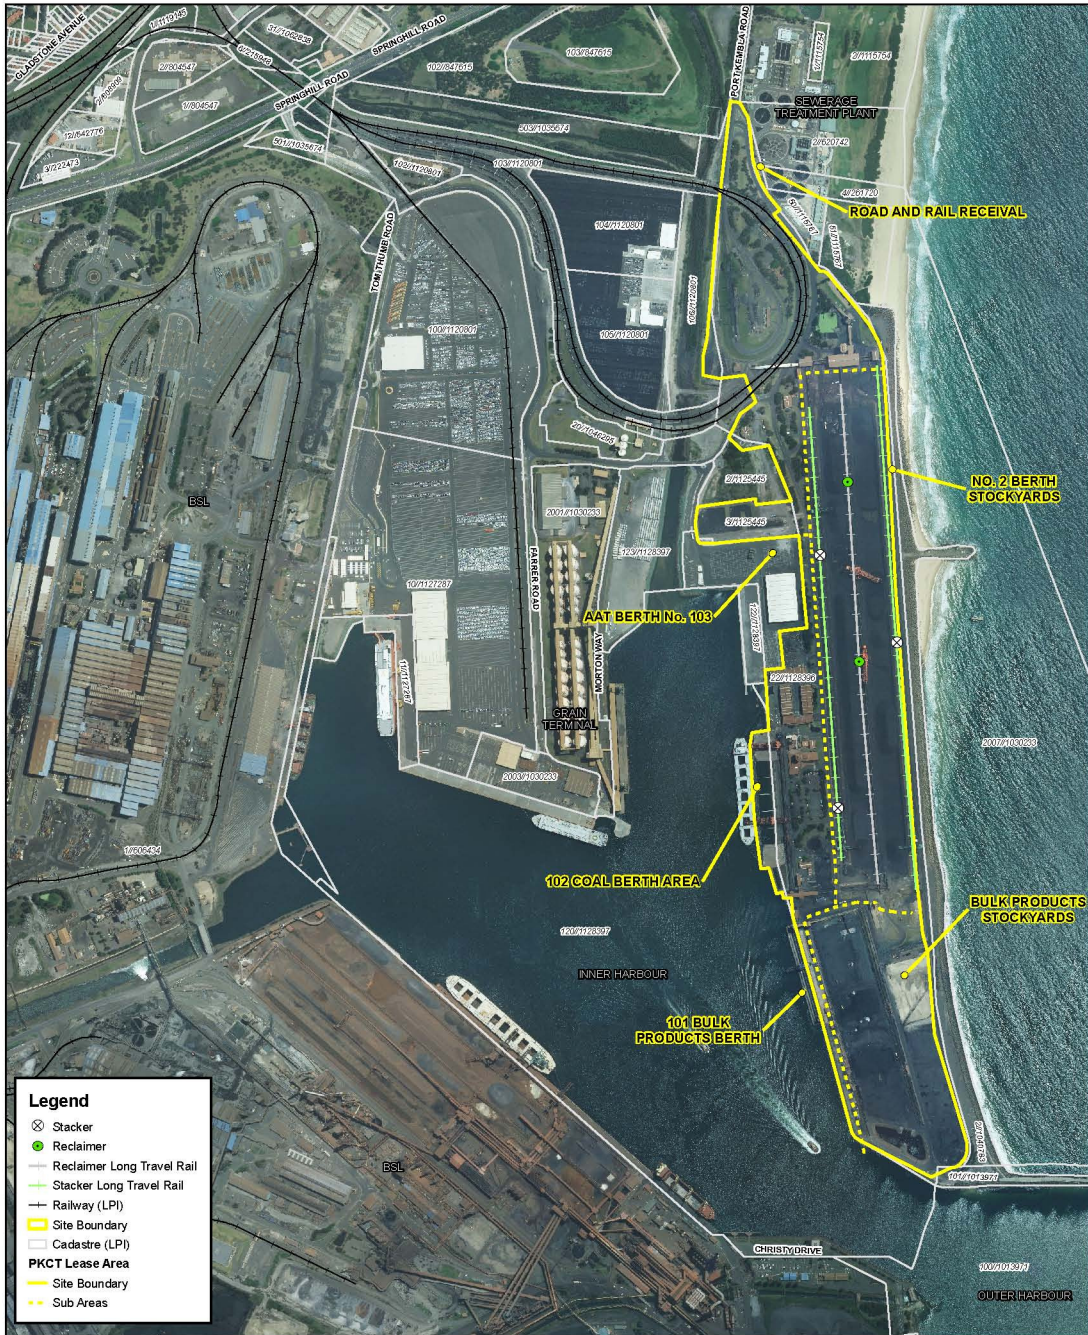
Figure 2-1 Site Plan for PKCT

Figure 2-1 and **Figure 2-2** shows the site plan of the PKCT site and its location relative to the surrounding receivers, respectively.

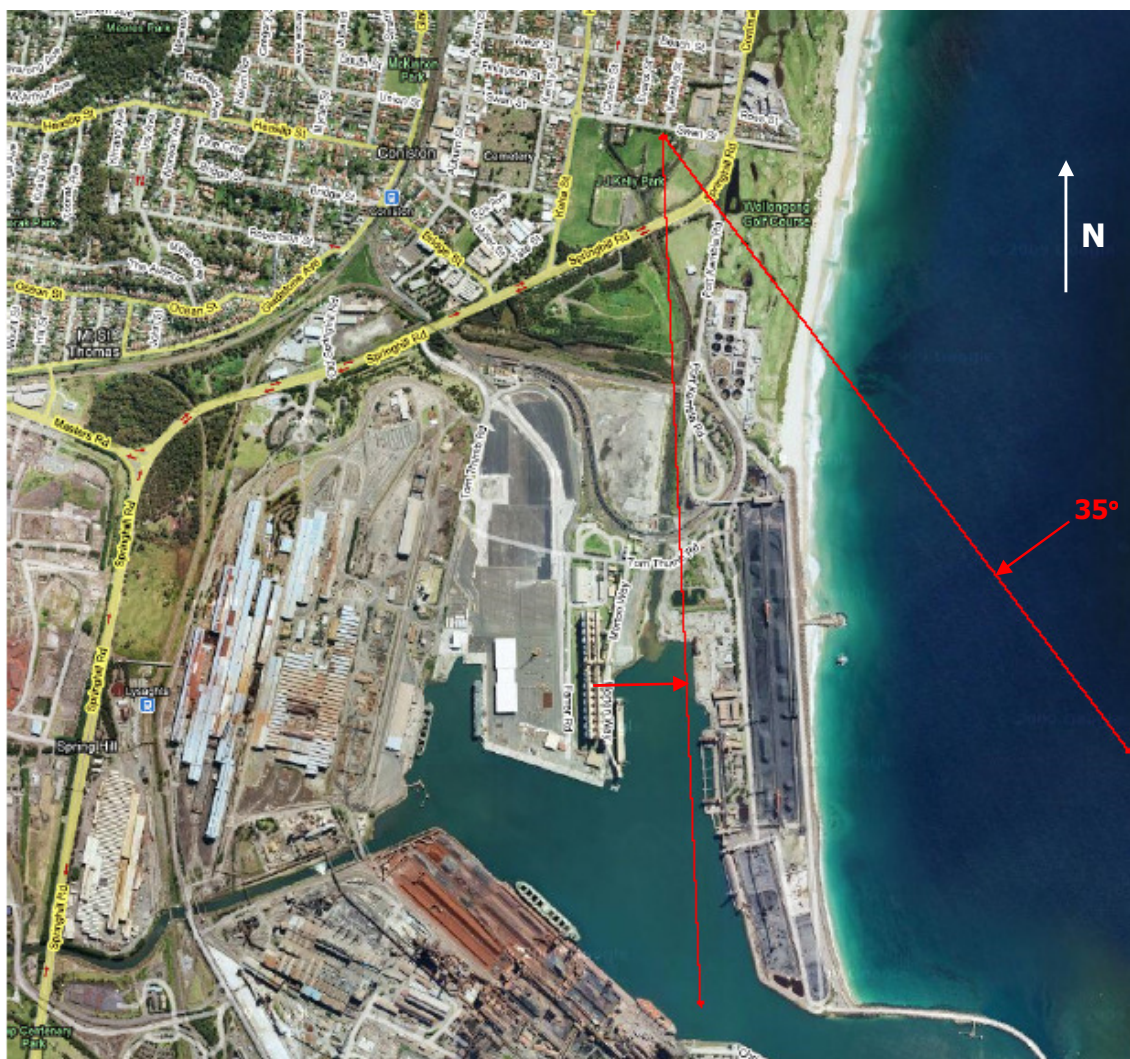
Figure 4-1 Monitoring Location 1 – Corner Swan & Kembla Streets

Figure 4-1 to **Figure 4-3** show the monitoring locations and the relative angular exposure to the PKCT operations. **Figure 4-4** shows the approximate locations where observations and measurements were taken in the vicinity of the receive area.

The angle of 35° is obtained by setting BarnOwl® to measure between angles 140° to 175°.

These sources were included in the BarnOwl[®] measurement segment (see **Figure 4-1**, **Figure 4-2** and **Figure 4-3**) and as such, have been included in the measurement contribution from the PKCT site.

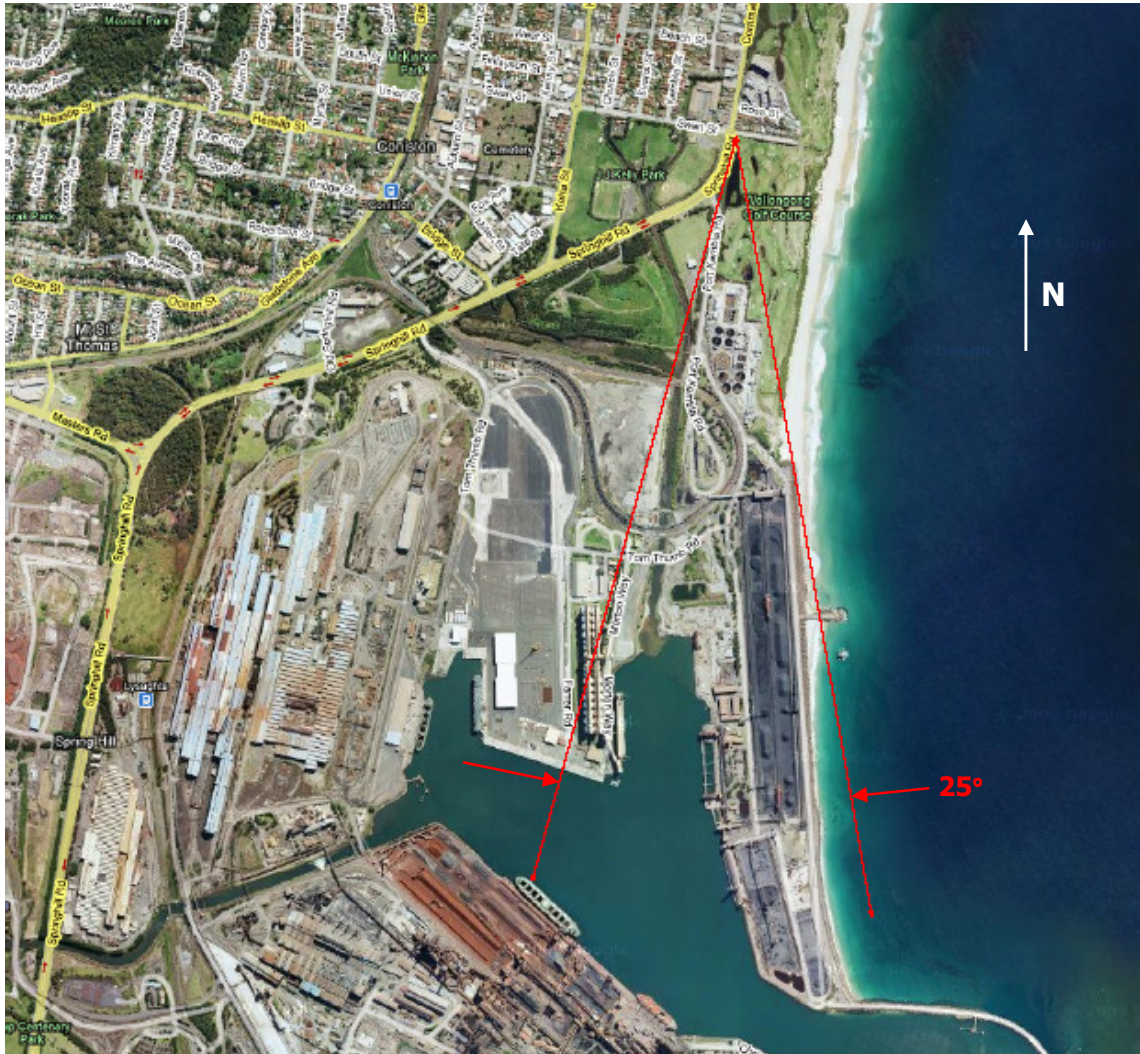
Figure 4-2 Monitoring Location 2 – Corner Swan & Corrimal Streets

The angle of 25° is obtained by setting BarnOwl® to measure between angles 170° to 195°.

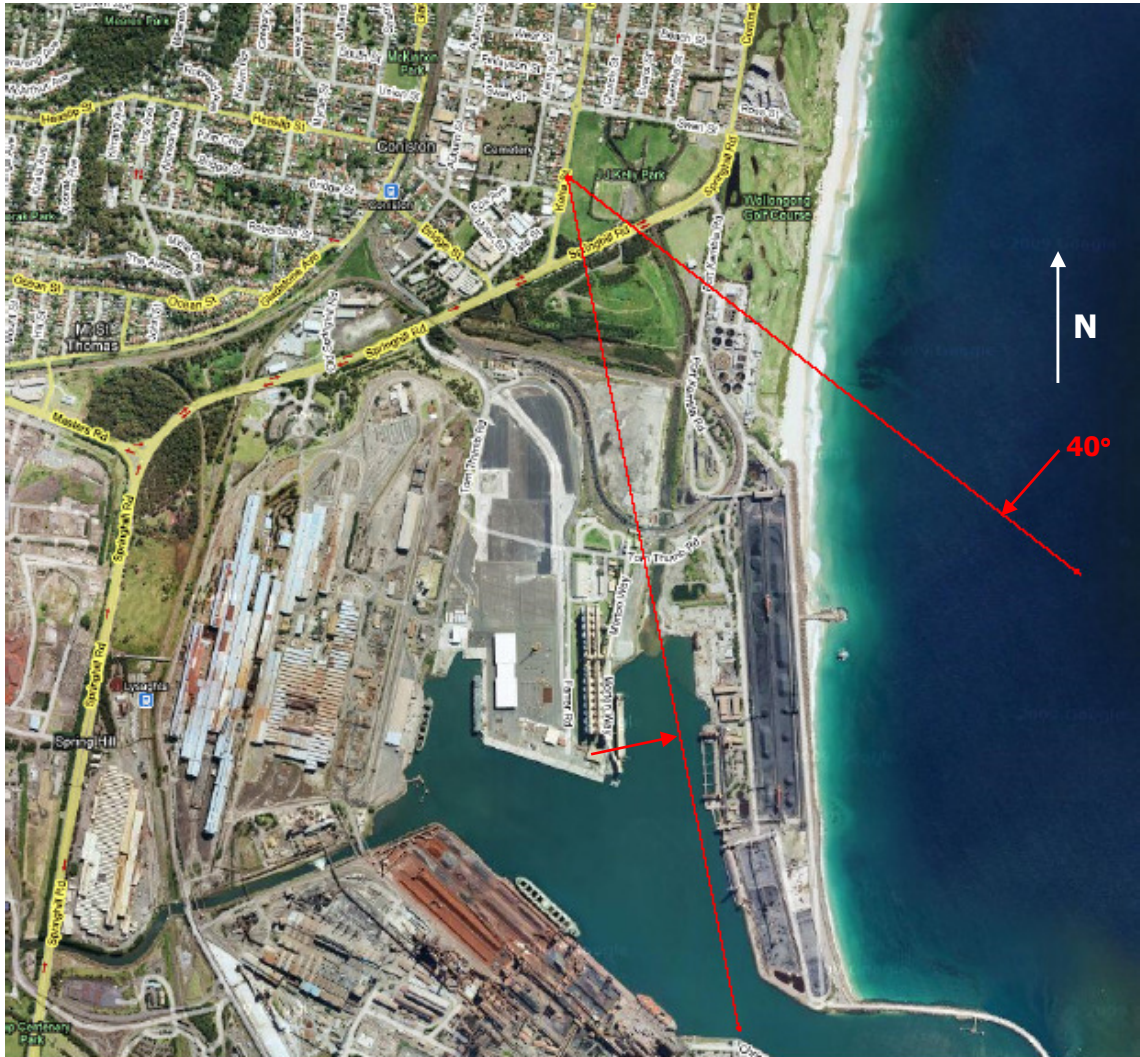
Figure 4-3 Monitoring Location 3 – Corner Keira & Fox Streets

The angle of 40° is obtained by setting BarnOwl® to measure between angles 125° to 165°.
