PKCT Community Consultative Committee Meeting 8th March 2017

*PKCT: A valued link in the
global coal supply chain*

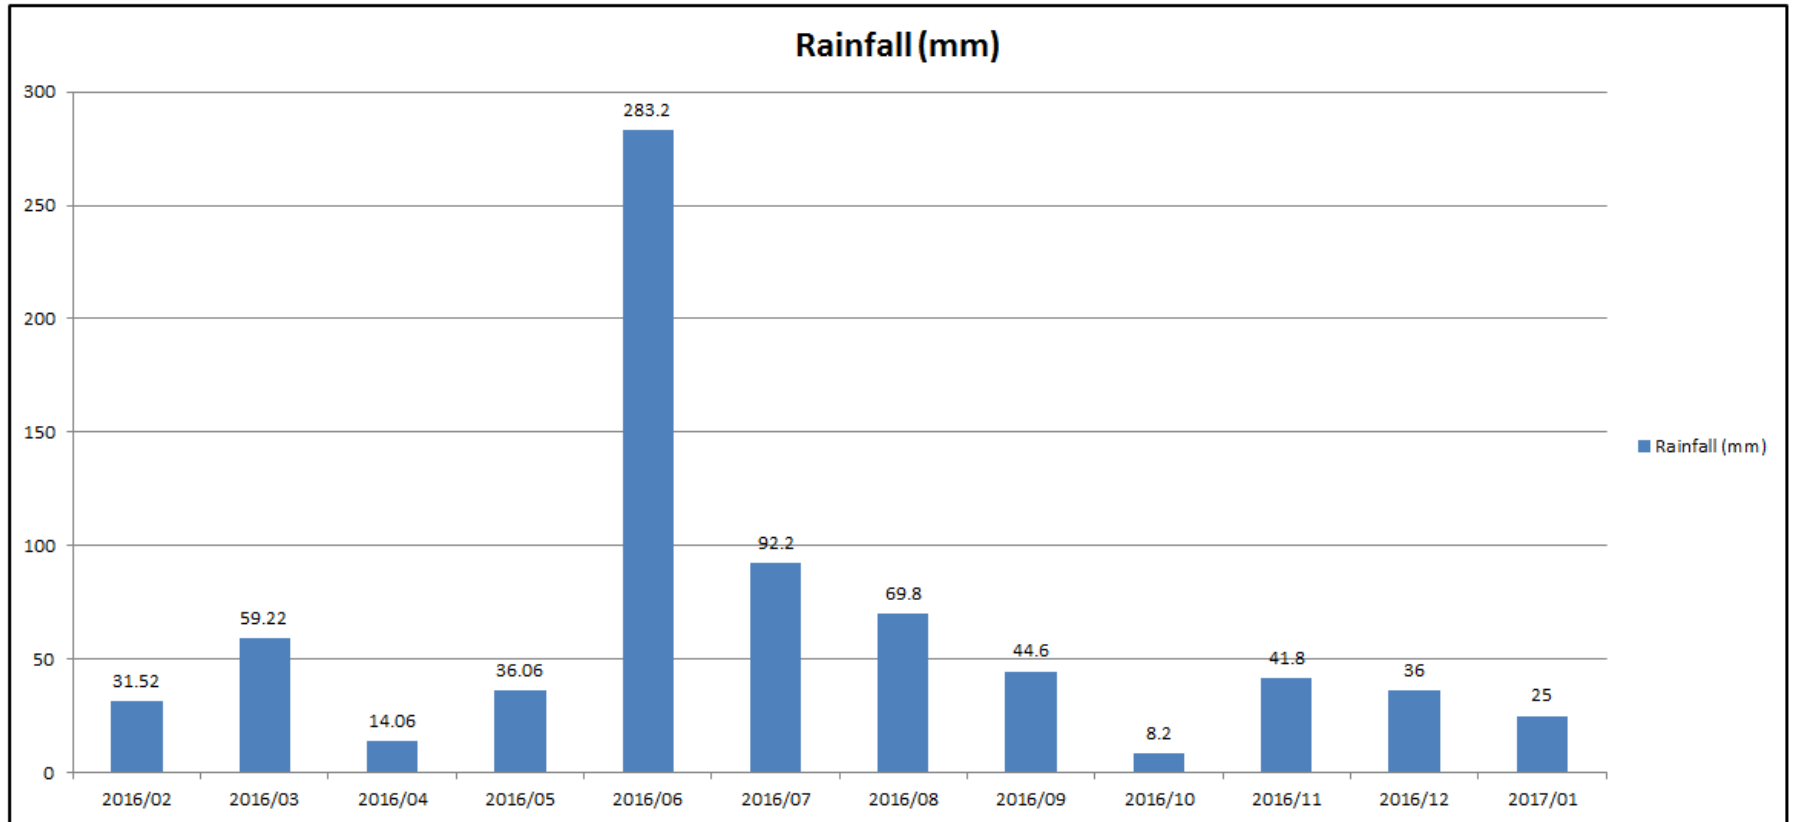
Rainfall

- Last significant rainfall was significant event across 26th Feb to 5th March 2017, 150mm prior event back on 4th and 5th June 2016, 245mm
- Very dry conditions over past few months other than recent rainfall event

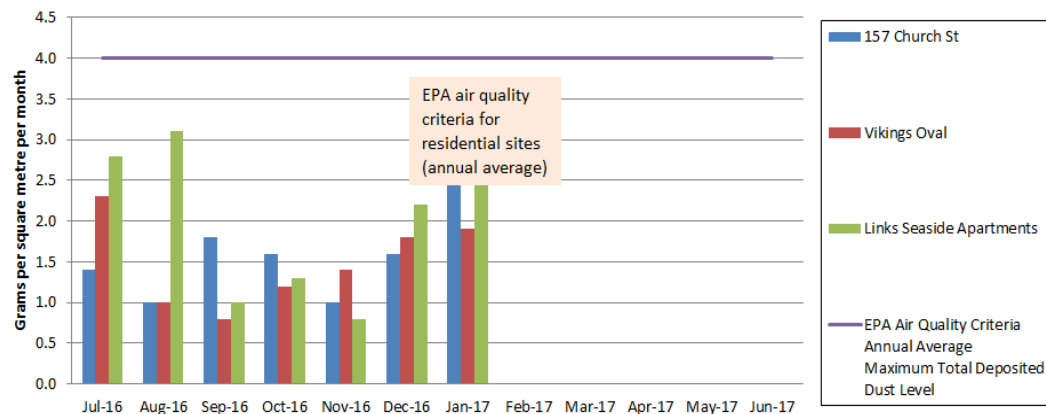
Insoluble Solids - Monthly Residential Dust Deposition Gauges

Since last meeting, the three residential dust gauges were all below EPA 12 month rolling average Air Quality Criteria for Insoluble Solids and Combustible Matter for all months

- Nb this criteria is an annual average.
- 12 month rolling average Insoluble Solids*
 - Ross St (Links) – 1.6 g/m² month
 - Church St – 1.3 g/m² month
 - Vikings Oval – 1.6 g/m² month
- 12 month rolling average Combustible Matter*
 - Ross St (Links) – 0.8 g/m² month
 - Church St – 0.6 g/m² month
 - Vikings Oval – 0.7 g/m² month

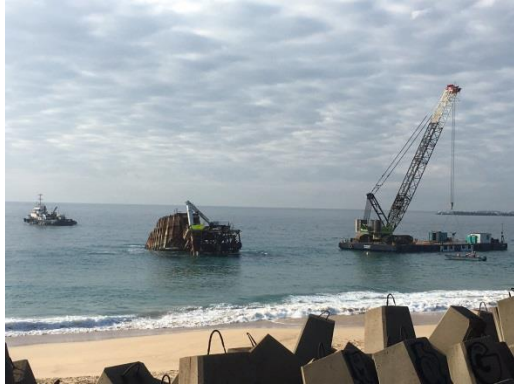
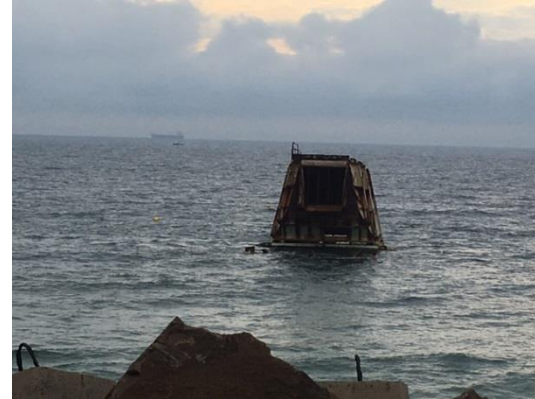
Wave Generator Update

- Some demolition done; ballast tanks damaged, dive works progressing to repair
- Following a heavy swell, sediment was deposited around structure. Dredge being organised, will need 4 calm days to complete, no timeframe given.
- Once free, structure will be towed out to sea and sunk.

RMS (Lucas Bryant is contact- 0477 740 413) arranging for its demolition and removal
