Agenda

PORT KEMBLA COAL TERMINAL DUST & WEATHER MONITOR LOCATIONS

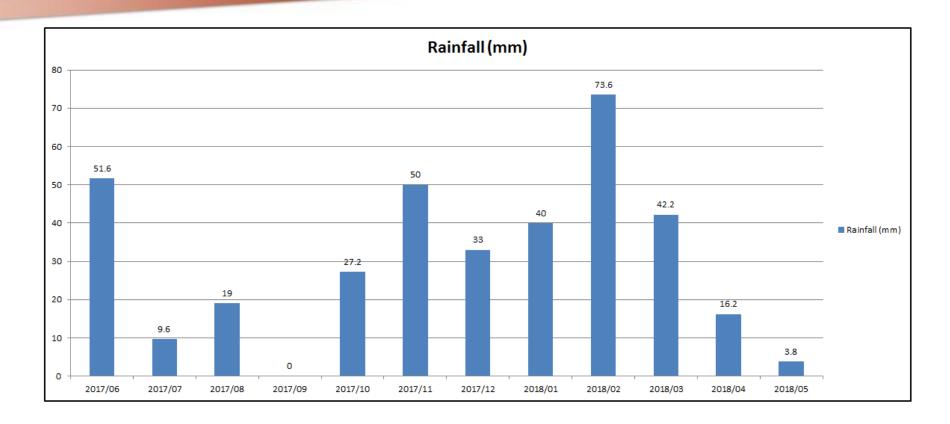
Rainfall

• Last significant rainfall February 2018, 73.6mm across month

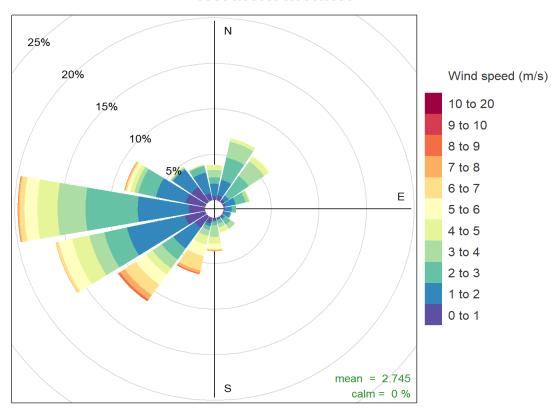
Northern monitor

Frequency of counts by wind direction (%)

- Wind results
 measured at
 Northern dust
 gauge at SWTP
 May 2018
- Mixture of wind directions. Most and strongest from the West followed by south west.
- 1m/sec = 3.6km/h

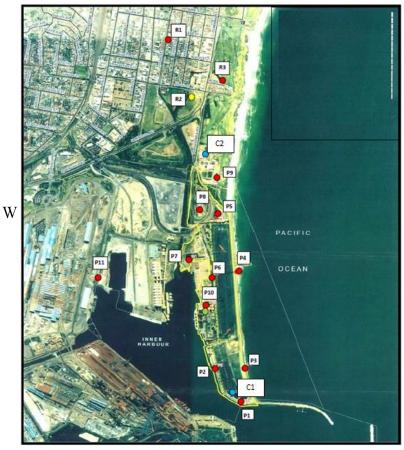
Dust Gauge Locations

EPL No.	PKCT No.	Dust Monitor Location Description	
1	P1	25m south of Bulk Products Berth (BPB)	
2	P2	40m south of Bulk Products Berth stockyard	
3	Р3	40m east of Bulk Products Berth stockyard	
4	P4	40m east Coal Berth stockyard	
5	P5	Northern Pond (Pond No.1)	
6	P6	40m west Coal Berth stockyard	
7	P7	250m west of Coal Berth stockyard	
8	P8	PKCT north truckwash	
9	P9	Wollongong Wastewater Treatment Plant	
15	P10	North of PKCT Planning Office	
17	P11	Entry Gate to BlueScope Ro Ro (Berth 109)	
12	R1	157 Church Street (two gauges)	
19	R2	Vikings Oval, Wollongong (two gauges)	
TBA	R3	Links Seaside Apartments	
20	C1	Continuous Dust Monitor 1	
21	C2	Continuous Dust Monitor 2

Dust Gauges- Environment Protection Licence monitoring sites

Sites denoted "P": industrial; "R": residential

- Continuous Dust Monitor Sites- additional
 - (a) BlueScope High Volume Sampler & dust gauge
 - (b) PKCT EPL Monitoring Site R2 (2 gauges) Weather stations
 - (a) at each continuous dust monitor site
 - (b) PKCT Main Control Room

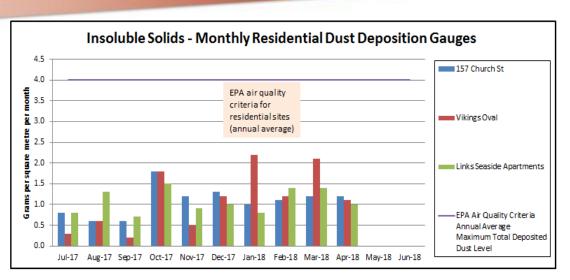
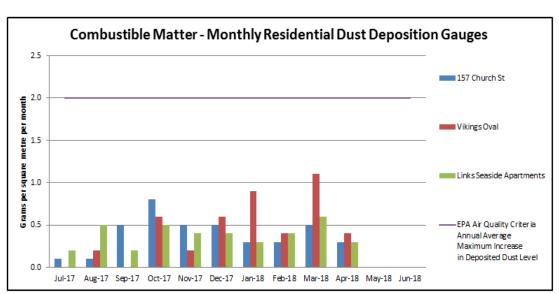
Depositional Dust - Residential

Since last meeting, the three residential dust gauges were all below EPA 12 month rolling average Air Quality Criteria for Insoluble Solids and Combustible Matter.

- Nb criteria below is an annual average. Data presented in graphs to left is monthly actuals.
- 12 month rolling average Insoluble Solids*
 - Ross St (Links) 1.0 g/m² month
 - Church St 1.0 g/m² month
 - Vikings Oval 1.0 g/m² month
- 12 month rolling average Combustible Matter*
 - Ross St (Links) 0.4 g/m² month
 - Church St 0.4 g/m² month
 - Vikings Oval 0.5 g/m² month

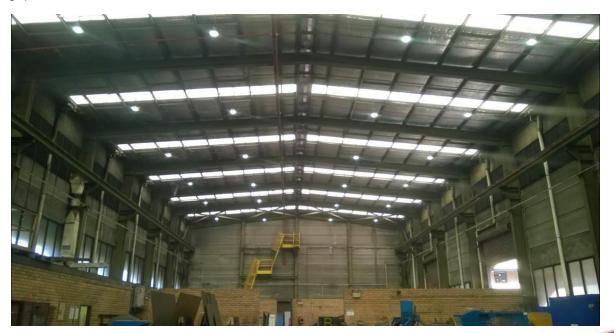
Lighting replacements in Workshop and Store

- Replaced all metal halide lights with new LED's
- Eastern workshop 40 lights, Western Workshop 34 lights, Main Store 23 lights
 - Total 97 lights changed out, with government rebate, the cost to replace each existing Metal Halide light fitting with an LED fitting was be \$100 (cost saving of \$500 per light fitting). This is cheaper than the cost of a replacement lamp in an existing fitting.
 - Power saving of over 68% of running costs (going from 400w to 127w also with daylight dimmer there will be ongoing power savings)
