PKCT Community Consultative Committee Meeting 22nd May 2019

*PKCT: A valued link in the
global coal supply chain*

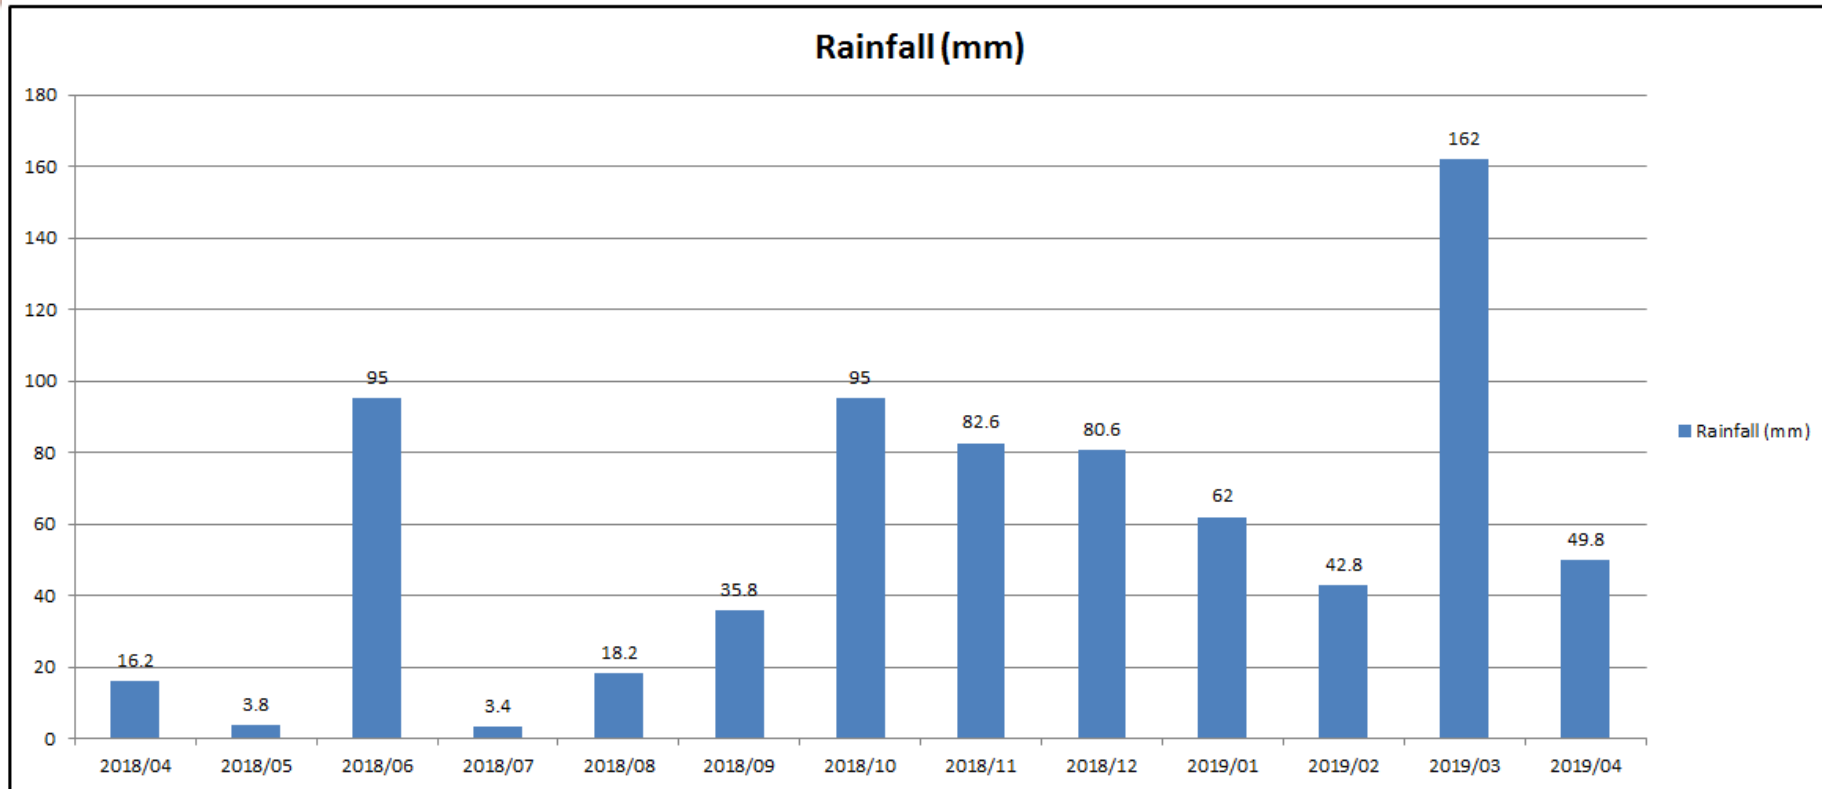
Rainfall

- Last significant rainfall March 2019, 162mm across month, 33mm in 1 hour

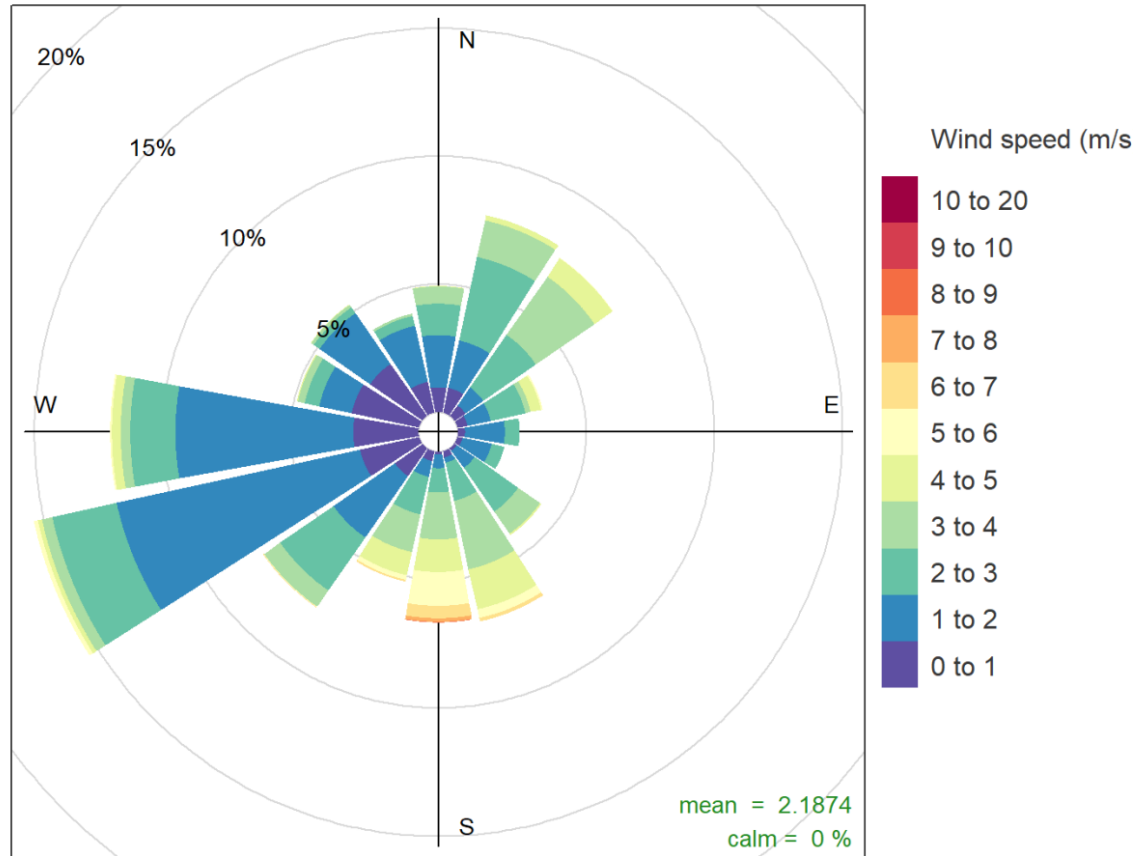
Wind – April 2019

Northern monitor

Frequency of counts by wind direction (%)

- Wind results measured at Northern dust gauge at SWTP April 2019.
- Mixture of wind directions. Most and strongest from the South West followed by West
- 1m/sec = 3.6km/h

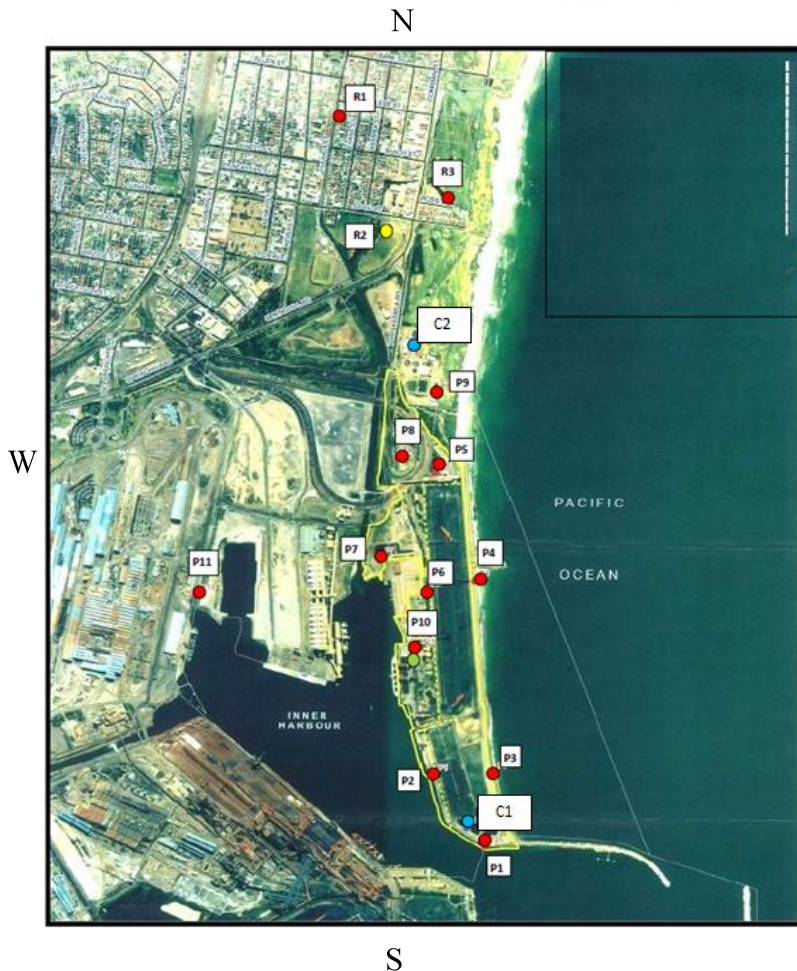
PORT KEMBLA COAL TERMINAL DUST & WEATHER MONITOR LOCATIONS

EPL No.	PKCT No.	Dust Monitor Location Description
1	P1	25m south of Bulk Products Berth (BPB)
2	P2	40m south of Bulk Products Berth stockyard
3	P3	40m east of Bulk Products Berth stockyard
4	P4	40m east Coal Berth stockyard
5	P5	Northern Pond (Pond No.1)
6	P6	40m west Coal Berth stockyard
7	P7	250m west of Coal Berth stockyard
8	P8	PKCT north truckwash
9	P9	Wollongong Wastewater Treatment Plant
15	P10	North of PKCT Planning Office
17	P11	Entry Gate to BlueScope Ro Ro (Berth 109)
12	R1	157 Church Street (two gauges)
19	R2	Vikings Oval, Wollongong (two gauges)
TBA	R3	Links Seaside Apartments
20	C1	Continuous Dust Monitor 1
21	C2	Continuous Dust Monitor 2

- # refer PKCT Environment Protection Licence(EPL) No. 1625 (EPA ID No.)
- Dust Gauges- Environment Protection Licence monitoring sites
Sites denoted "P": industrial; "R": residential
 - Continuous Dust Monitor Sites- additional
 - (a) BlueScope High Volume Sampler & dust gauge
(b) PKCT EPL Monitoring Site R2 (2 gauges)
 - Weather stations
 - (a) at each continuous dust monitor site ●
 - (b) PKCT Main Control Room ●

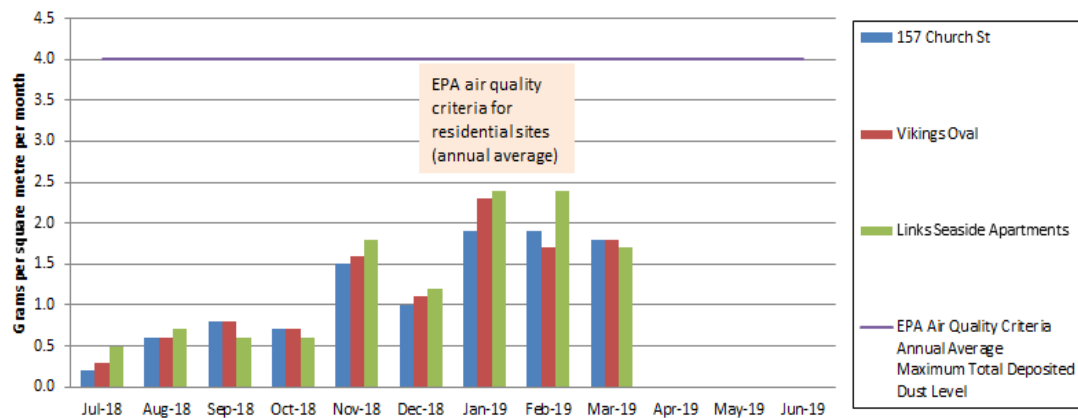
Insoluble Solids - Monthly Residential Dust Deposition Gauges

Since last meeting, the three residential dust gauges were all below EPA 12 month rolling average Air Quality Criteria for Insoluble Solids and Combustible Matter.

Nb criteria below is an annual average. Data presented in graphs to left is monthly actuals.

- Ross St (Links) – 1.2 g/m² month
- Church St – 1.0 g/m² month
- Vikings Oval – 1.1 g/m² month

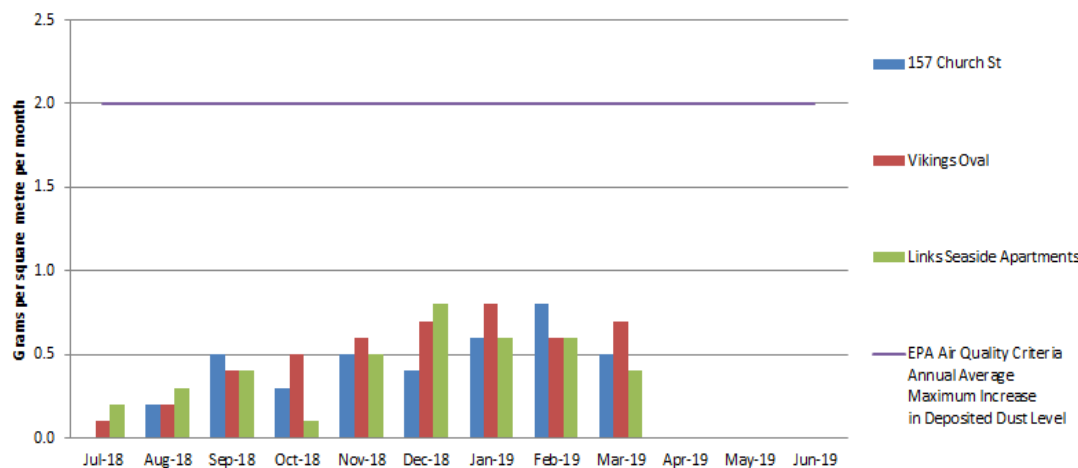
Combustible Matter - Monthly Residential Dust Deposition Gauges

12 month rolling average Combustible Matter*

- Ross St (Links) – 0.4 g/m² month
- Church St – 0.4 g/m² month
- Vikings Oval – 0.5 g/m² month

*April 2018 to March 2019

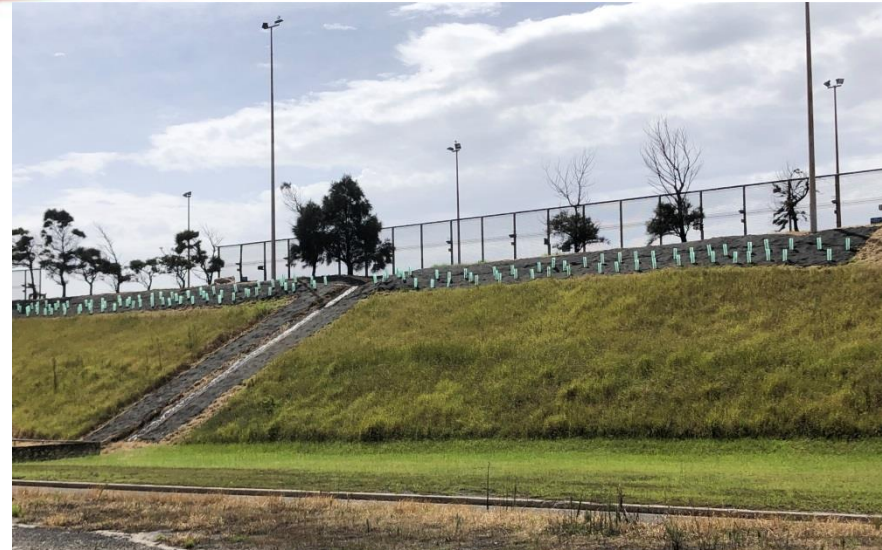
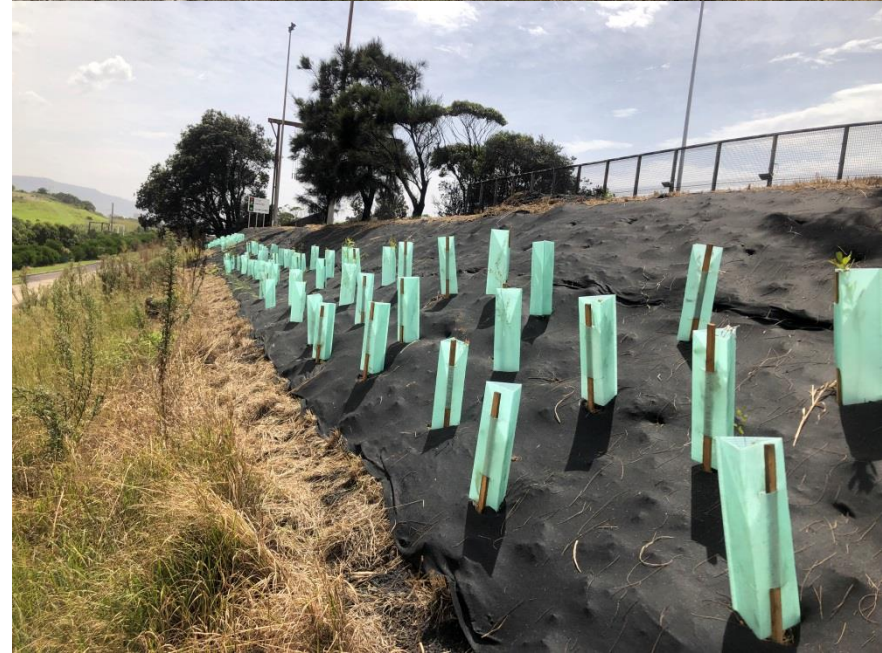
Road Receival Berm Tree Planting

- In Feb and March, 600 trees and shrubs and a watering system were planted along the top of the Road Receival Berm.
- Native plants including banksia, leptospermum sp and lamandra.
- Plants will assist in providing a visual screen to western residents, provide habitat and will assist with dust capture

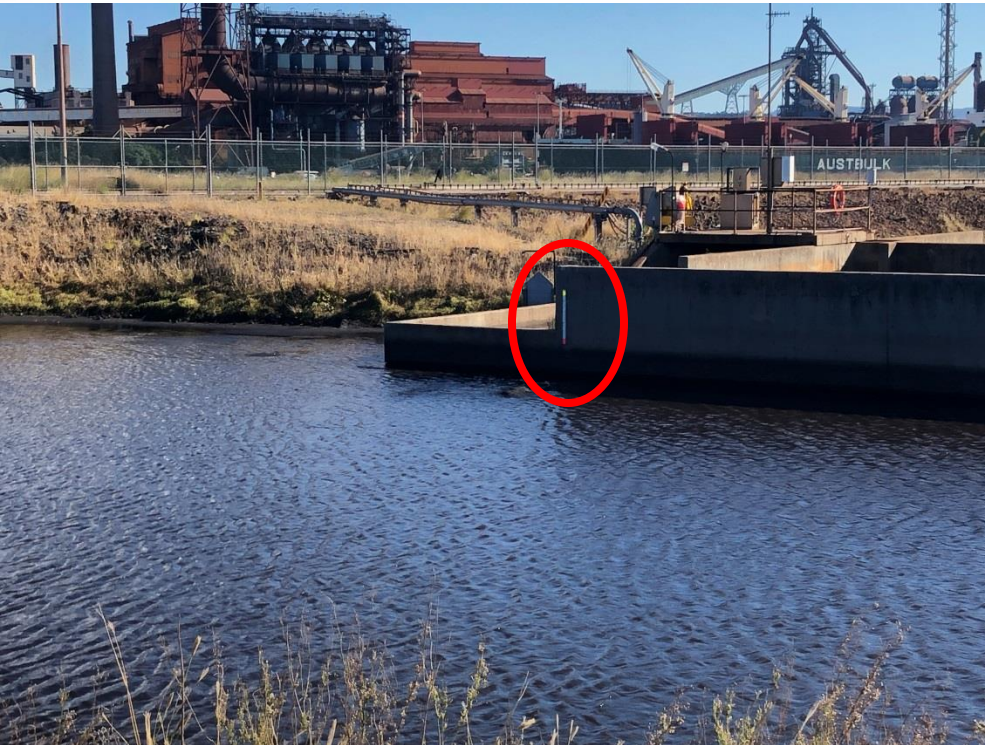
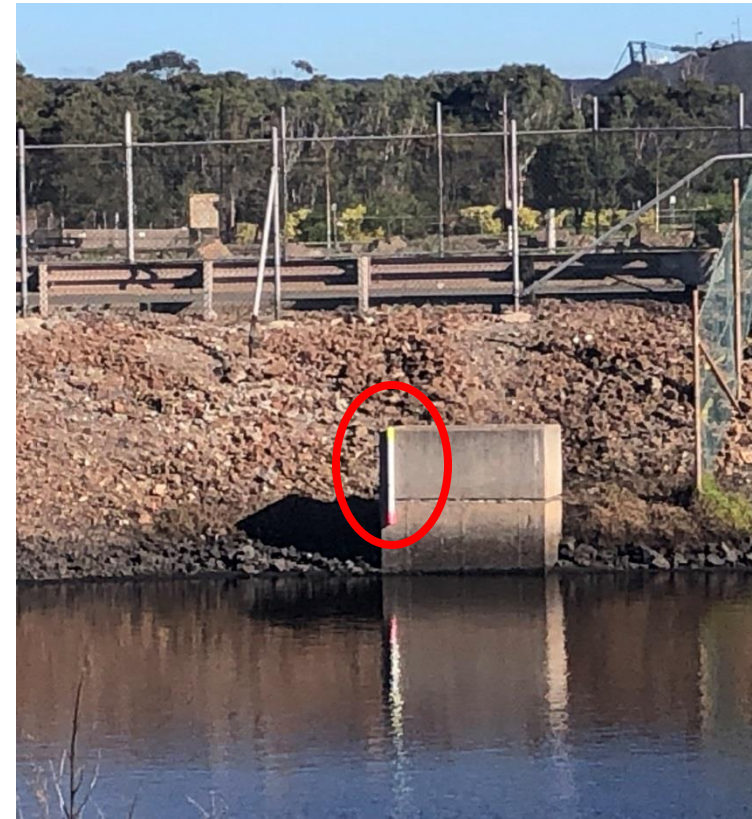
Pond Sediment Markers installed

New pond markers are being installed around PKCT Ponds to assist in managing sediment levels.
