# PKCT Community Consultative Committee Meeting

Meeting No. 54  
Nov 27<sup>th</sup> 2024

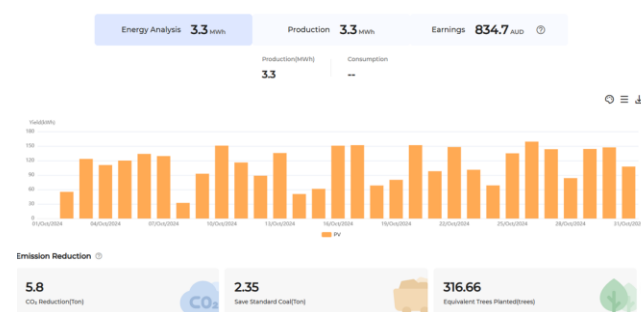
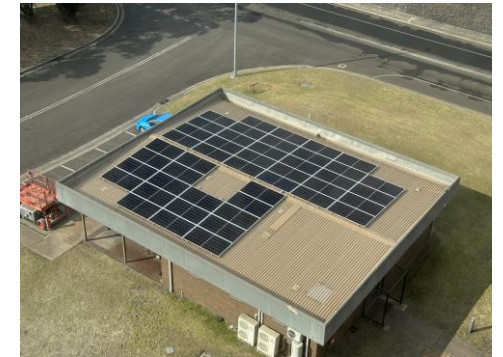
## Greenhouse Gas Reduction

PKCT is currently investigating options to reduce our greenhouse gas emissions. In August we installed a 24.36kW solar system on our Training Room. The system will be monitored for effectiveness and if successful, further options for solar will be investigated on our other buildings.

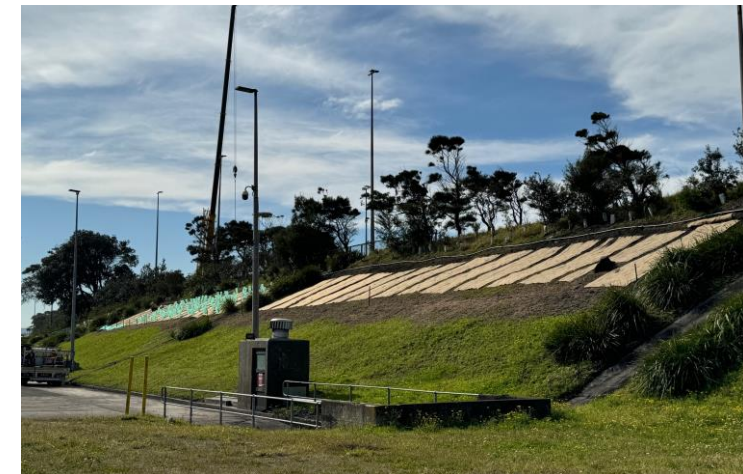
## Road Receptal Landscape Project

PKCT's long-term road receptal landscaping project began in January and February 2019. This major landscaping project aimed at developing a visual screen for residents to the west of the terminal, shielding truck tipping activities through the planting of 600 trees and approximately 200 sedges on the adjacent berm. The trees planted were a mix of native trees, shrubs and sedges and will take around 3-5 years to become established. In July 2023 PKCT completed planting of a further 550 native trees and shrubs in the area. The trees and shrubs, once established will further enhance the biodiversity of at the terminal and provide additional safe habitat for birds and other species. A further ~1200 trees and shrubs were planted in August 2024. In addition to the screening, as they grow, the trees will assist with dust reduction in the area.
